**CLIMATE ADAPTATION PLAN**

**KENNEBUNKPORT WASTEWATER  
TREATMENT FACILITY AND SEWER  
COLLECTION SYSTEM**

**Kennebunkport, Maine**

**July 2019**

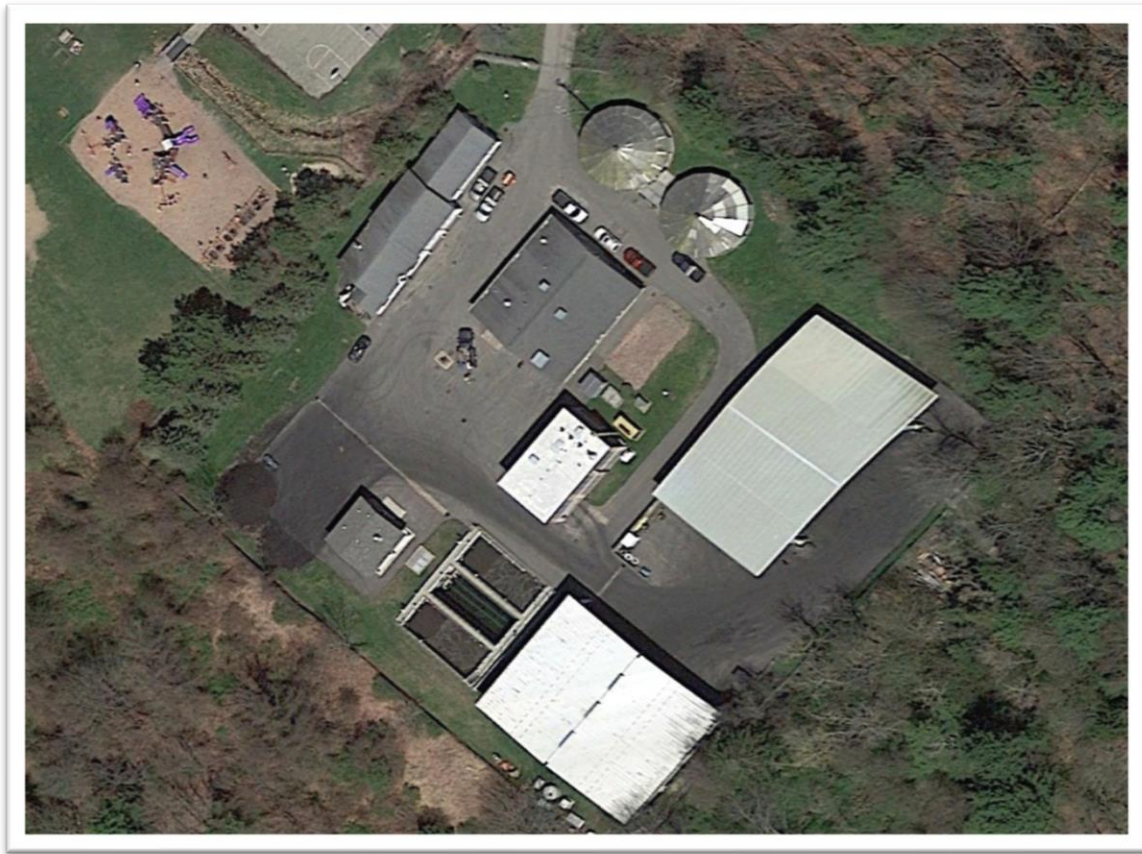
**FIGURE 1 - KENNEBUNKPORT WWTF**

The Kennebunkport Waste Water Treatment Facility (WWTF) commenced operations in 1974 at its current location on Recreation Way in the Town of Kennebunkport (Figure 1 in Appendix A). The WWTF can provide secondary level treatment and nutrient removal by way of the Modified Ludzack-Ettinger (MLE) process. The facility is permitted to provide secondary level treatment including year-round chlorine disinfection to flows up to an average daily flow of 0.70 million gallons per day (MGD). The WWTF has undergone 4 major upgrades in 1979, 1997, 2005 and 2010. The facility receives wastewater from the sanitary sewer collection system that serves approximately 3,500 customers in the Town of Kennebunkport. The WWTF is equipped with two parallel preliminary grit screens, three parallel rectangular aeration basins capable of providing nitrification and denitrification, two 40-foot diameter secondary clarifiers, two parallel chlorine contact chambers, two 0.5-meter sludge belt filter presses, an outdoor 370-kW stand-by power generator, administration building operations building, screenings building, sludge dewatering building, and two biosolids composting structures.

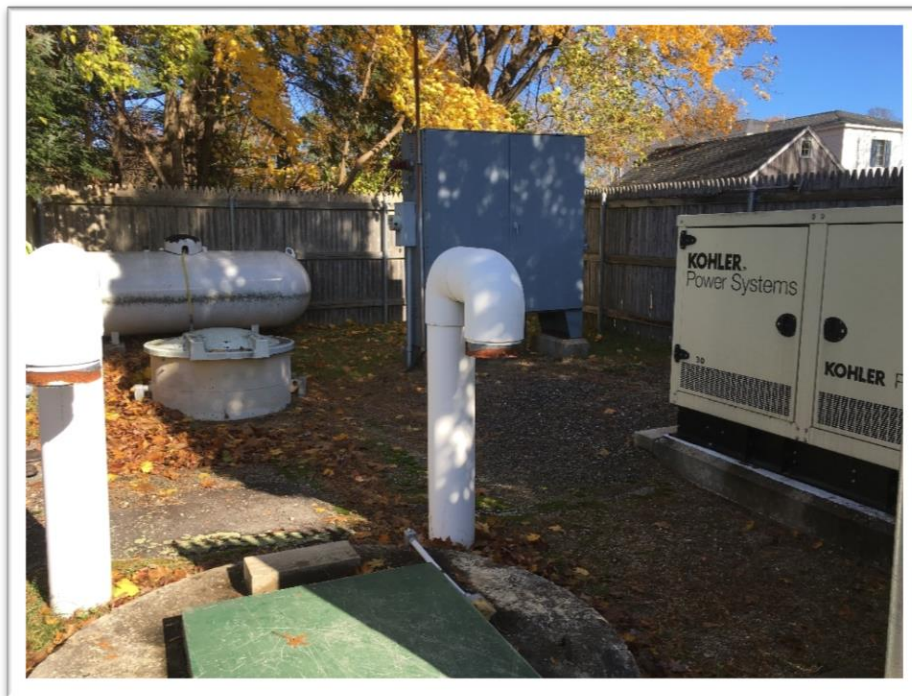
**FIGURE 2 – MILL LANE PUMP STATION**

The Mills Lane pump station is a flooded-suction type pump station located at 5 Mill Lane (Figure 2). The station was constructed in 1979 and has not undergone any major upgrades. The station is equipped with two 7.5-HP flooded suction centrifugal pumps and an above-ground electrical control panel adjacent to the station's wet-well. Power is provided by overhead utility power lines connected to the pump station's electrical panel. A dedicated 25-kW Kohler brand propane-fueled standby power generator powers the station during utility power failure. The station is equipped with both local alarm and radio telemetry systems.

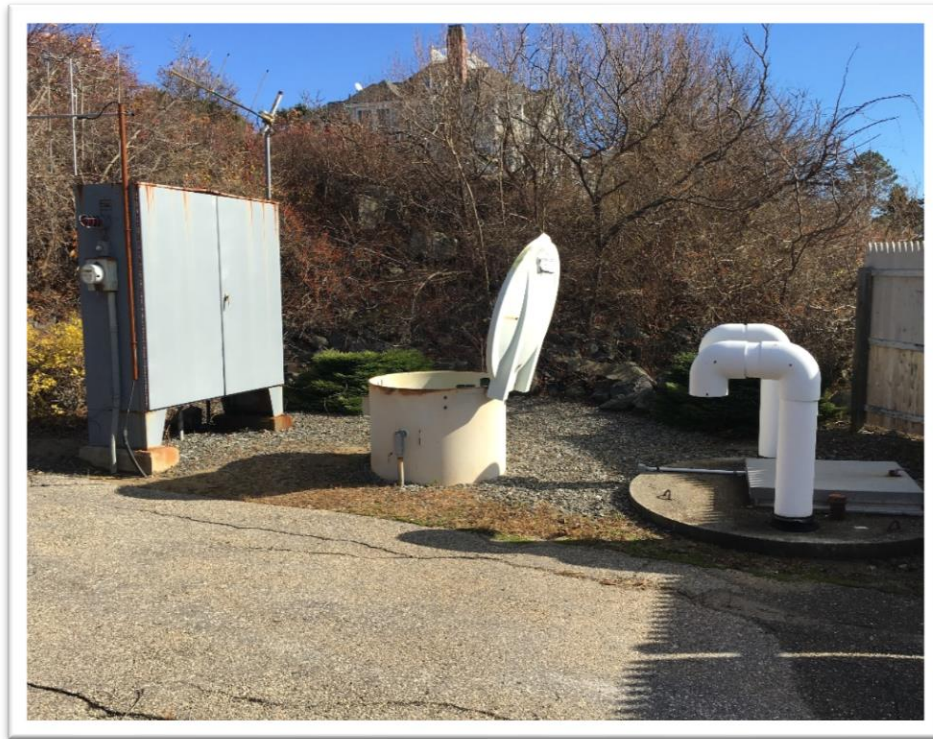
**FIGURE 6 – OCEAN AVENUE PUMP STATION**

The Ocean Avenue pump station is a flooded-suction type pump station located at 192 Ocean Avenue (Figure 6). The station was originally constructed in 1984 and has not undergone any major upgrades. The station is equipped with two 3-HP flooded-suction centrifugal pumps and an

above-ground electrical control panel adjacent to the station's wet-well. Power is provided by overhead utility power lines connected to the pump station's electrical panel by underground conduit. The station is equipped with a stand-by power portable generator connection port. The station has both local alarm and radio telemetry systems.

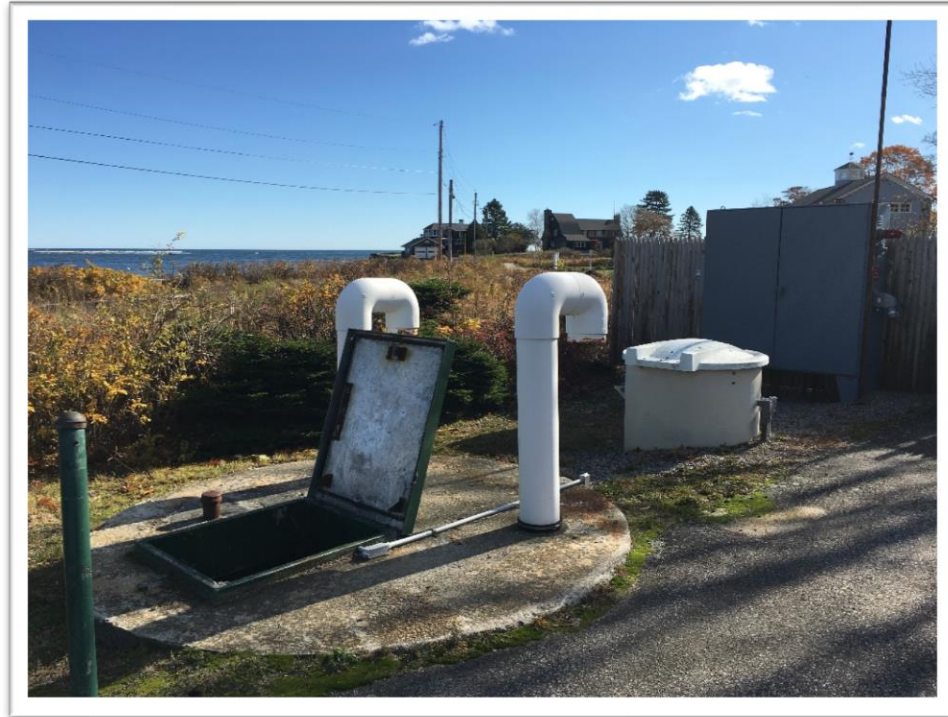
**FIGURE 7 – TURBATS CREEK PUMP STATION**

The Turbats Creek pump station is a flooded-suction type pump station located at 71 Turbats Creek Road (Figure 7). The station was originally constructed in 1984 and has not undergone any major upgrades. The station is equipped with two 30-HP flooded-suction centrifugal pumps and an above-ground electrical control panel mounted to a building adjacent to the station's wet-well. Power is provided by overhead utility power lines connected to the pump station's electrical panel via underground conduit. A dedicated 45-kW Onan brand diesel-fueled standby power generator powers the station during utility power failure. The station is equipped with a local alarm and telemetry system.

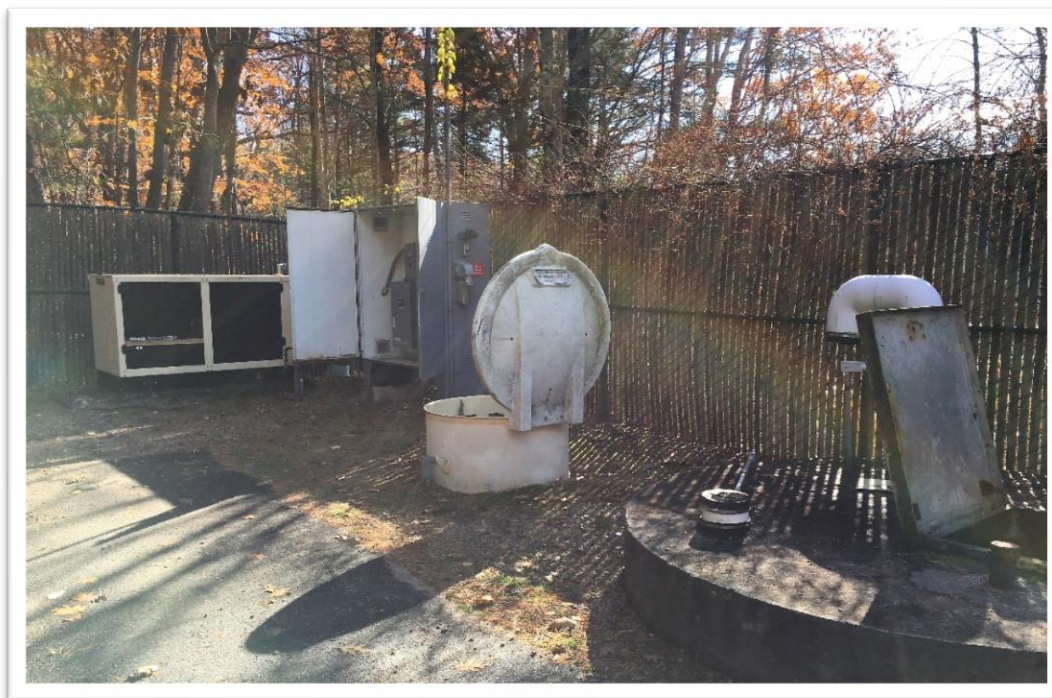
**FIGURE 8 – WILDES DISTRICT ROAD PUMP STATION**

The Wildes District Road pump station is a flooded-suction type pump station located at 131 Wildes District Road (Figure 8). The station was originally constructed in 1983 and has not undergone any major upgrades. The station is equipped with two 30-HP flooded-suction centrifugal pumps and an above-ground electrical control panel adjacent to the station’s wet-well. Power is provided by overhead utility power lines connected to the pump station’s electrical panel via underground electrical conduit. A dedicated 45-kW Kohler brand propane-fueled standby power generator powers the station during utility power failure. The station has both local alarm and radio telemetry systems.

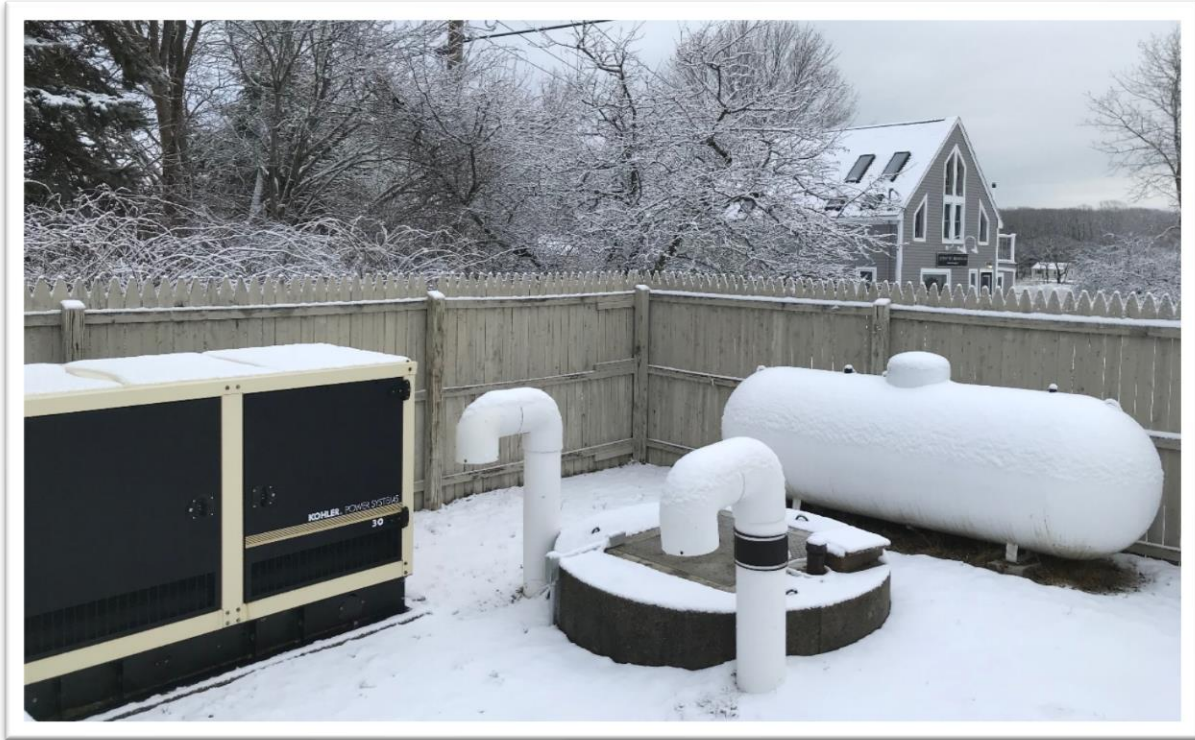
**FIGURE 10 – CAPE SQUARE (PORPOISE) PUMP STATION**

The Cape Square (Porpoise) pump station is a flooded-suction type pump station located at 174 Main Street (Figure 10). The station was originally constructed in 1985 and has not undergone any major upgrades. It is equipped with two 10-HP flooded-suction centrifugal pumps and an above-ground electrical control panel adjacent to the station’s wet-well. Power is provided by overhead utility power lines connected to the pump station’s electrical panel via underground electrical conduit. A dedicated 25-kW Kohler brand propane-fueled standby power generator powers the station during utility power failure. The station has both local alarm and radio telemetry systems.

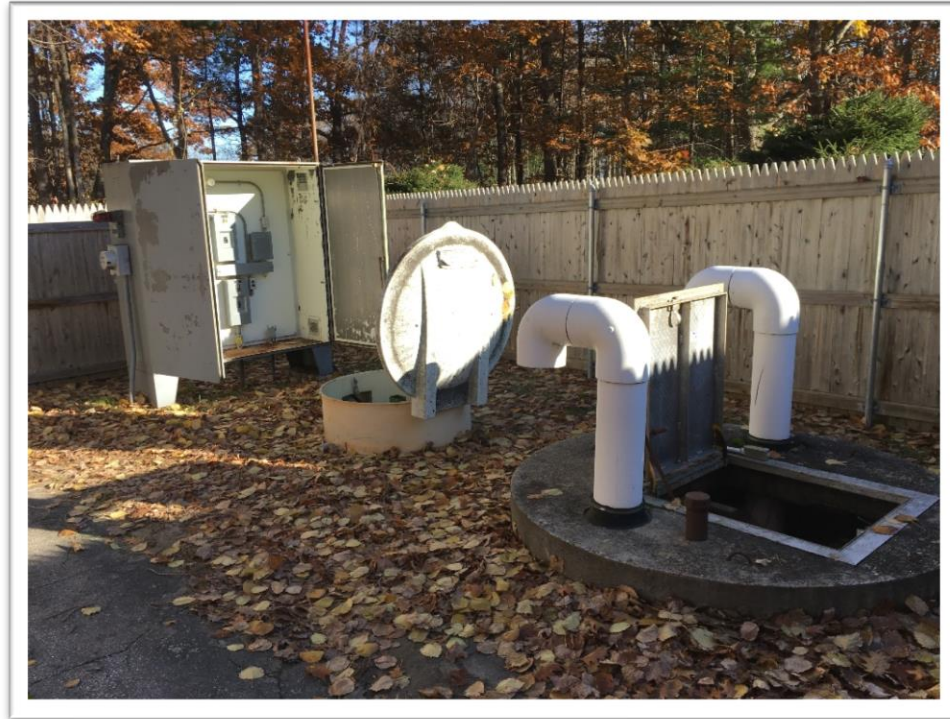
**FIGURE 11 – MILLS ROAD PUMP STATION**

The Mills Road pump station is a flooded-suction type pump station located at 47 Mills Road (Figure 11). The station was originally constructed in 1983 and has not undergone any major upgrades. It is equipped with two 2-HP flooded-suction centrifugal pumps and an above-ground electrical control panel adjacent to the station's wet-well. Power is provided by overhead utility power lines connected to the pump station's electrical panel via underground electrical conduit. The station is equipped with a stand-by power portable generator connection port. The station has both local alarm and radio telemetry systems.

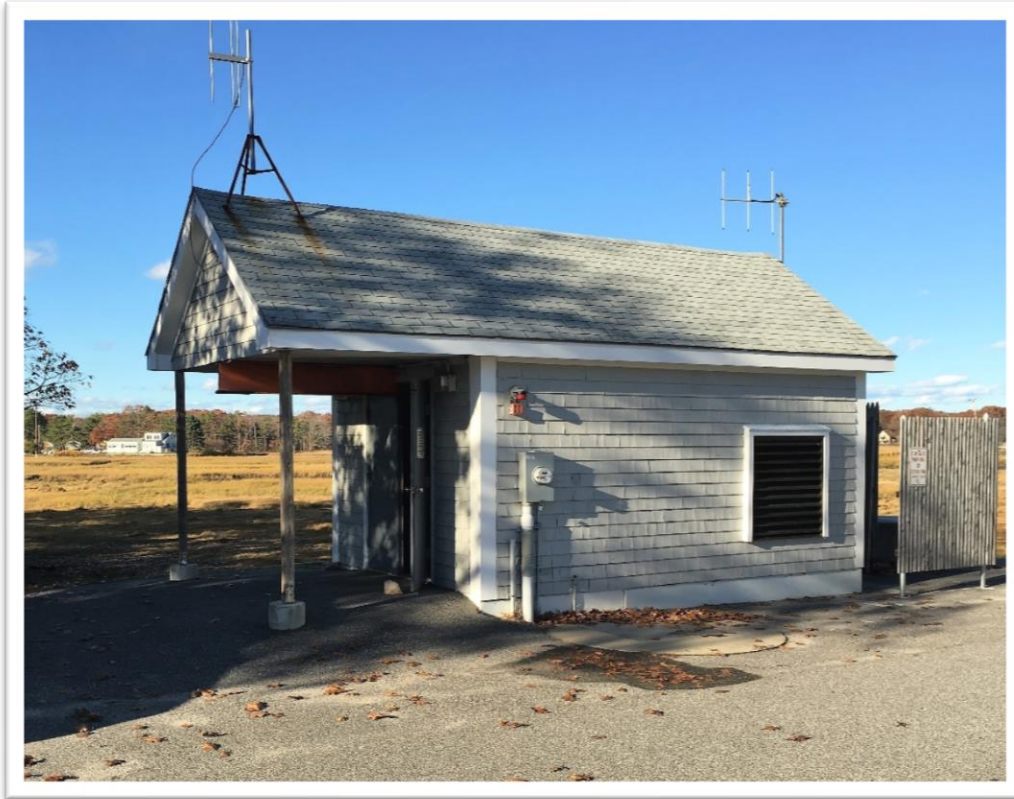
**FIGURE 12 –KING’S HIGHWAY-MAIN PUMP STATION**

The King's Highway- Main pump station is a suction-prime type pump station located at 200 Kings Highway (Figure 12). The station was originally constructed in 1992 and has undergone one major upgrade in 2012. It is equipped with two 45-HP suction-prime centrifugal pumps located in the lower level of the pump station building. Power is provided by overhead utility power lines connected to the pump station building via underground electrical conduit. The pump control panels are located in the lower level of the pump station building. A dedicated 38-kW Kohler brand diesel-fueled standby power generator powers the station during utility power failure. The station has both local alarm and radio telemetry systems.

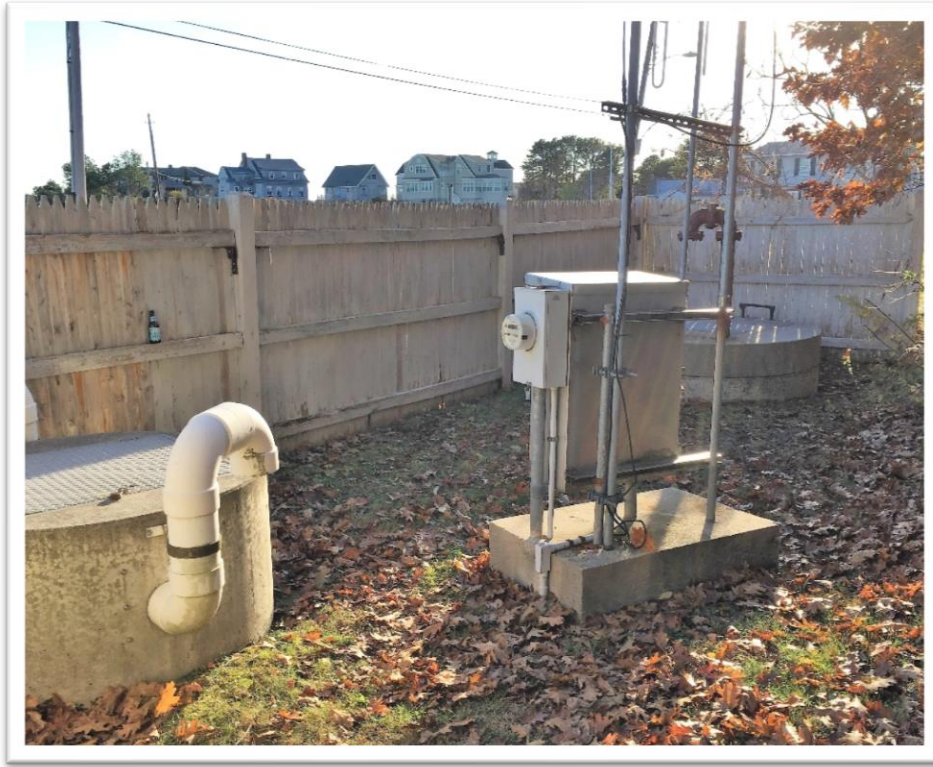
**FIGURE 13 – KING’S LANE PUMP STATION**

The King’s Lane pump station is a suction-prime type pump station located at 318 King’ Highway (Figure 13). The station was originally constructed in 1992 and has not undergone any major upgrades. It is equipped with two 13.5-HP suction-prime centrifugal pumps and an above-ground electrical control panel adjacent to the station’s wet-well. Power is provided by overhead utility power lines connected to the pump station’s electrical panel via underground electrical conduit. The station is equipped with a stand-by power portable generator connection port. The station has both local alarm and radio telemetry systems.

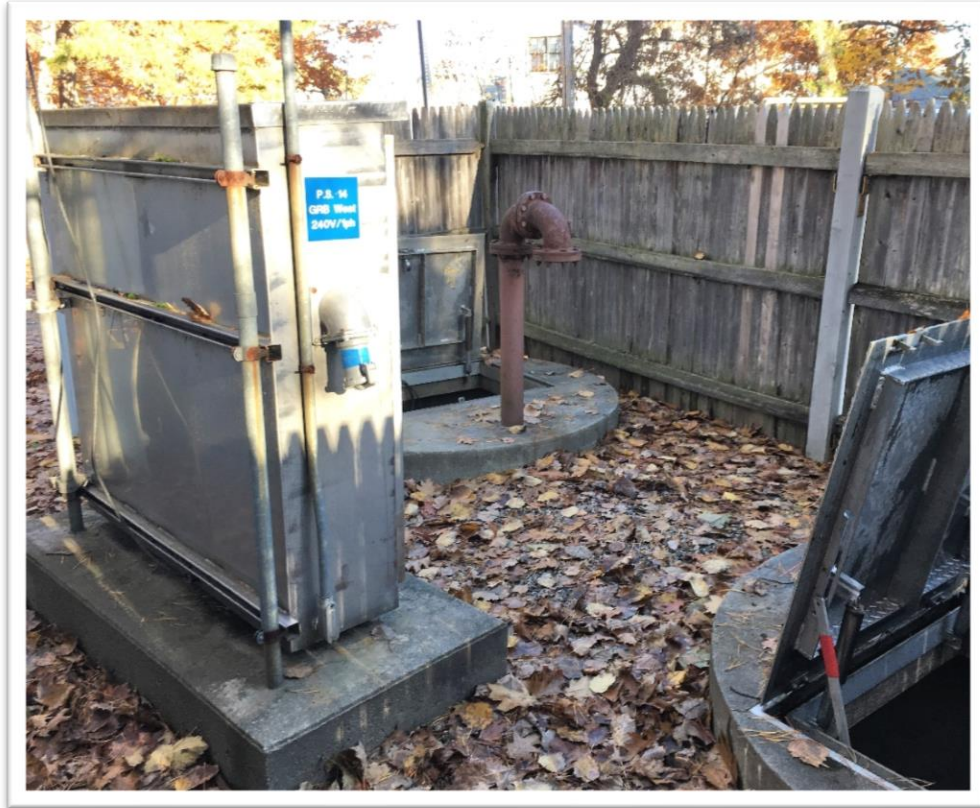
**FIGURE 14 – KING’S HIGHWAY SUBMERSIBLE PUMP STATION**

The King’s Highway-Submersible pump station is a submersible type pump station located at 124 Kings Highway (Figure 14). The station was originally constructed in 1992 and has not undergone any major upgrades. It is equipped with two 5-HP submersible centrifugal pumps and an above-ground electrical control panel adjacent to the station’s wet-well. Power is provided by overhead utility power lines connected to the pump station’s electrical panel via underground electrical conduit. The station is equipped with a stand-by power portable generator connection port. The station has both local alarm and radio telemetry systems.

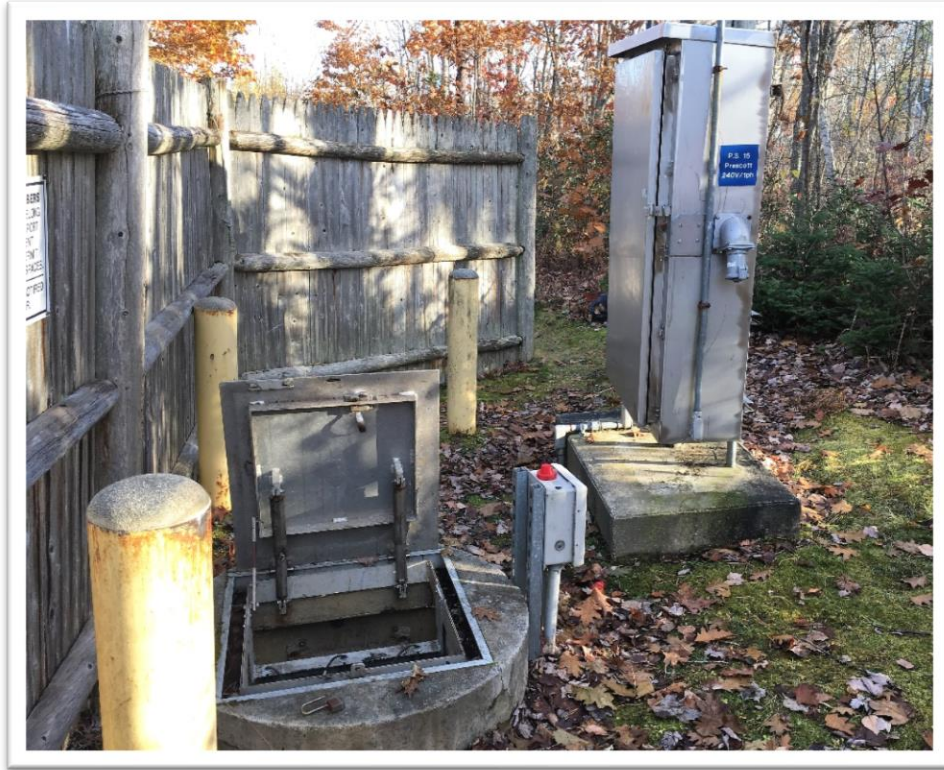
**FIGURE 15 – PRESCOTT DRIVE PUMP STATION**

The Prescott Drive pump station is a submersible type pump station located at 6 Prescott Drive (Figure 15). The station was originally constructed in 1992 and has not undergone any major upgrades. It is equipped with one 2-HP submersible centrifugal pump and an above-ground electrical control panel adjacent to the station's wet-well. Power is provided by overhead utility power lines connected to the pump station's electrical panel via underground electrical conduit. The station is equipped with a stand-by power portable generator connection port. The station has local visual and auditory alarm system.

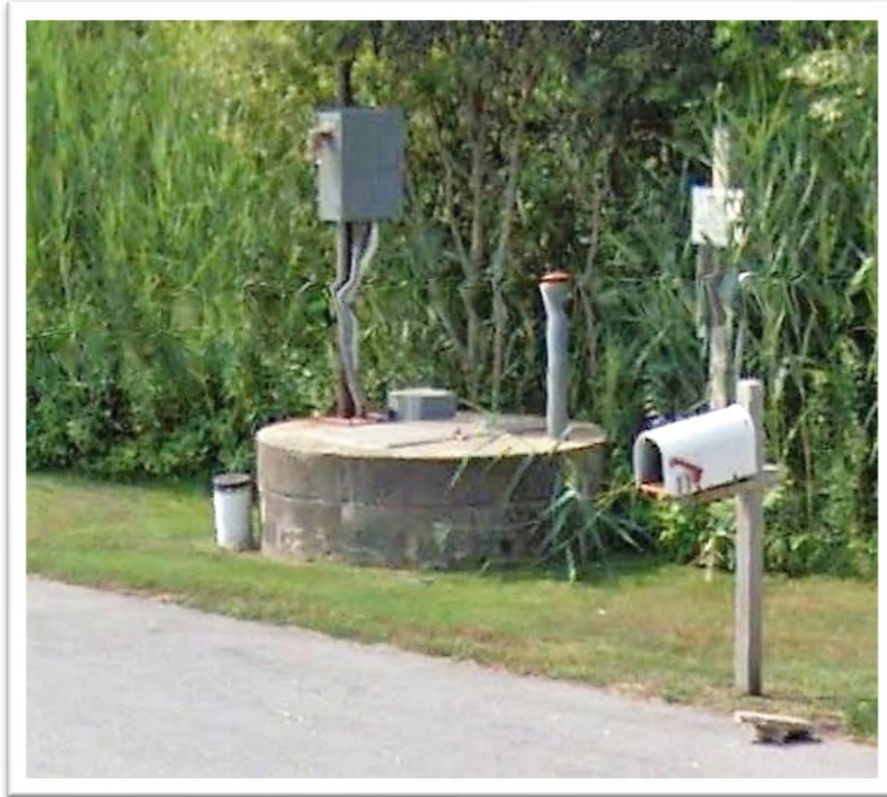
**FIGURE 16 – WASHINGTON COURT PUMP STATION**

The Washington Court pump station is a submersible type pump station located at 9A Washington Court (Figure 16). The station was originally constructed in 1992 and has not undergone any major upgrades. It is equipped with two 2-HP submersible centrifugal pump and an above-ground electrical control panel adjacent to the station's wet-well. Power is provided by overhead utility power lines connected to the pump station's electrical panel via underground electrical conduit. The station is equipped with a stand-by power portable generator connection port. The station has local visual and auditory alarm system.

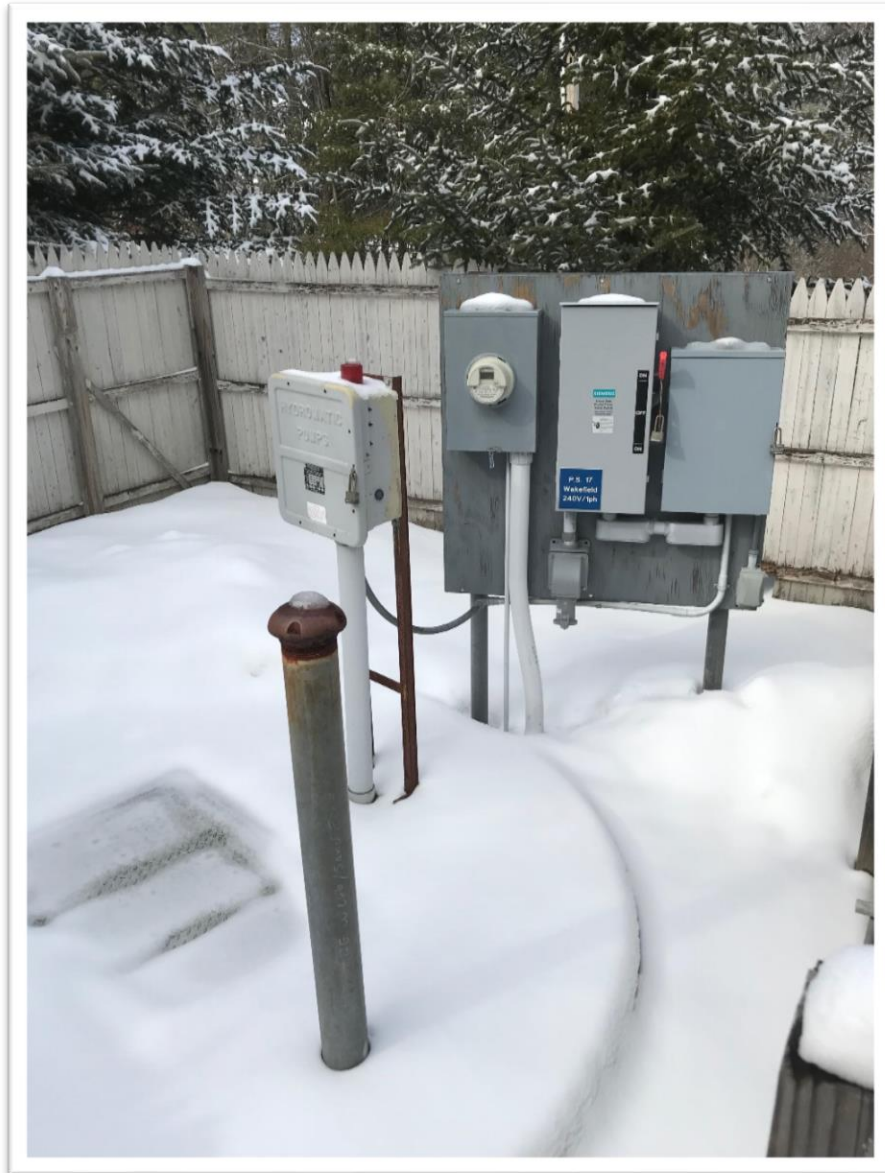
**FIGURE 17 – WAKEFIELD PASTURE ROAD PUMP STATION**

The Wakefield Pasture Road pump station is a submersible type pump station located at 22 Wakefield Pasture Road (Figure 16). The station was originally constructed in 1992 and has not undergone any major upgrades. It is equipped with one 2-HP submersible centrifugal pump and an above-ground electrical control panel adjacent to the station’s wet-well. Power is provided by overhead utility power lines connected to the pump station’s electrical panel via underground electrical conduit. The station is equipped with a stand-by power portable generator connection port. The station has local visual and auditory alarm system.

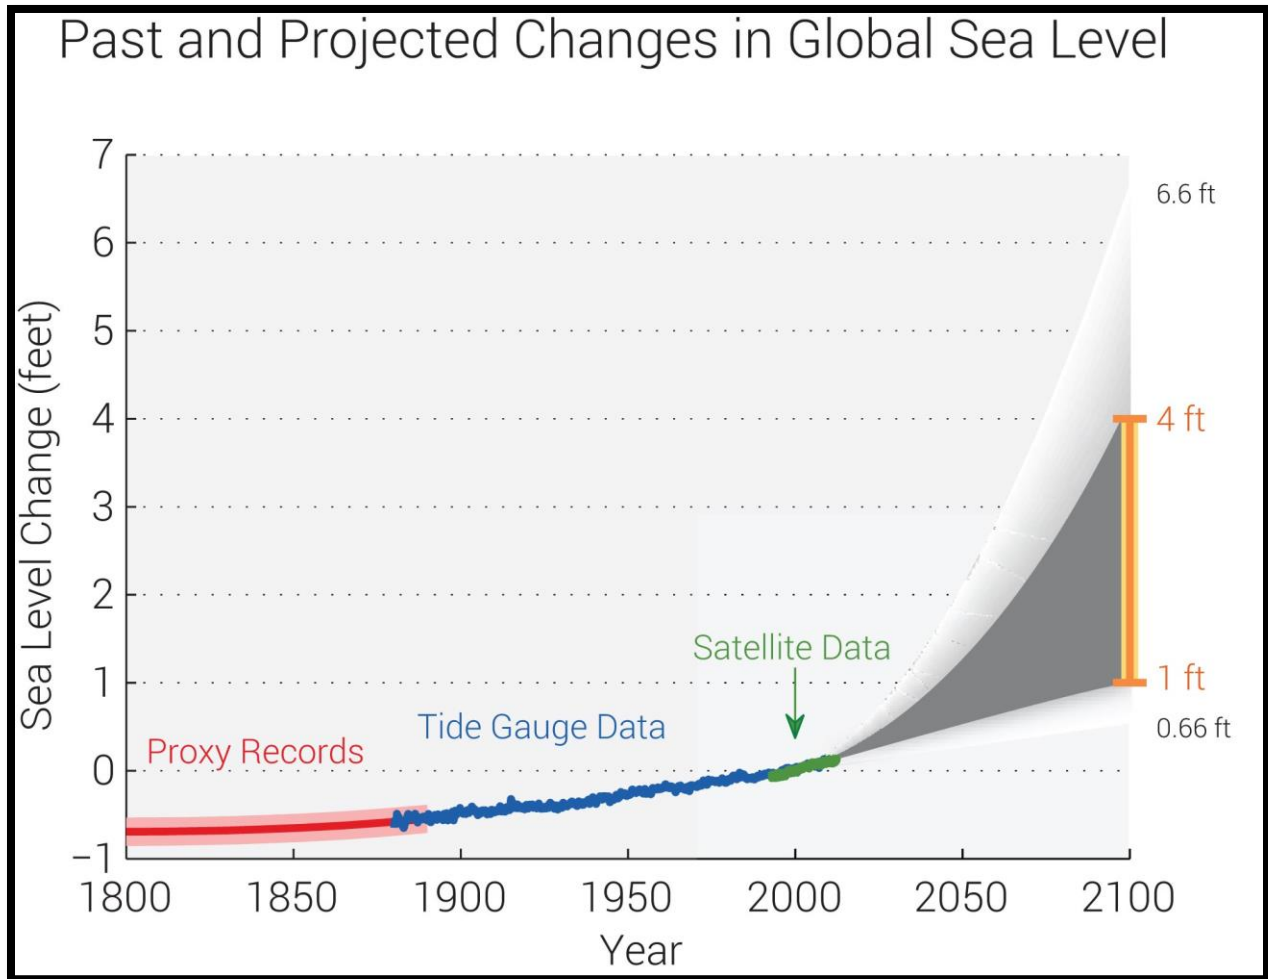
**FIGURE 20 – NOAA SEA LEVEL RISE SCENARIOS**

Climate change may also cause or contribute to sea level rise and marsh migration along Maine’s coast. NOAA climatology models have been used to simulate a range of climate change scenarios including the expected magnitude of sea level rise (Figure 20). The orange line at right in Figure 20 shows the most likely range of 1 to 4 feet by 2100 based on an assessment of scientific studies, which falls within a larger possible range of 0.66 feet to 6.6 feet<sup>2</sup>.

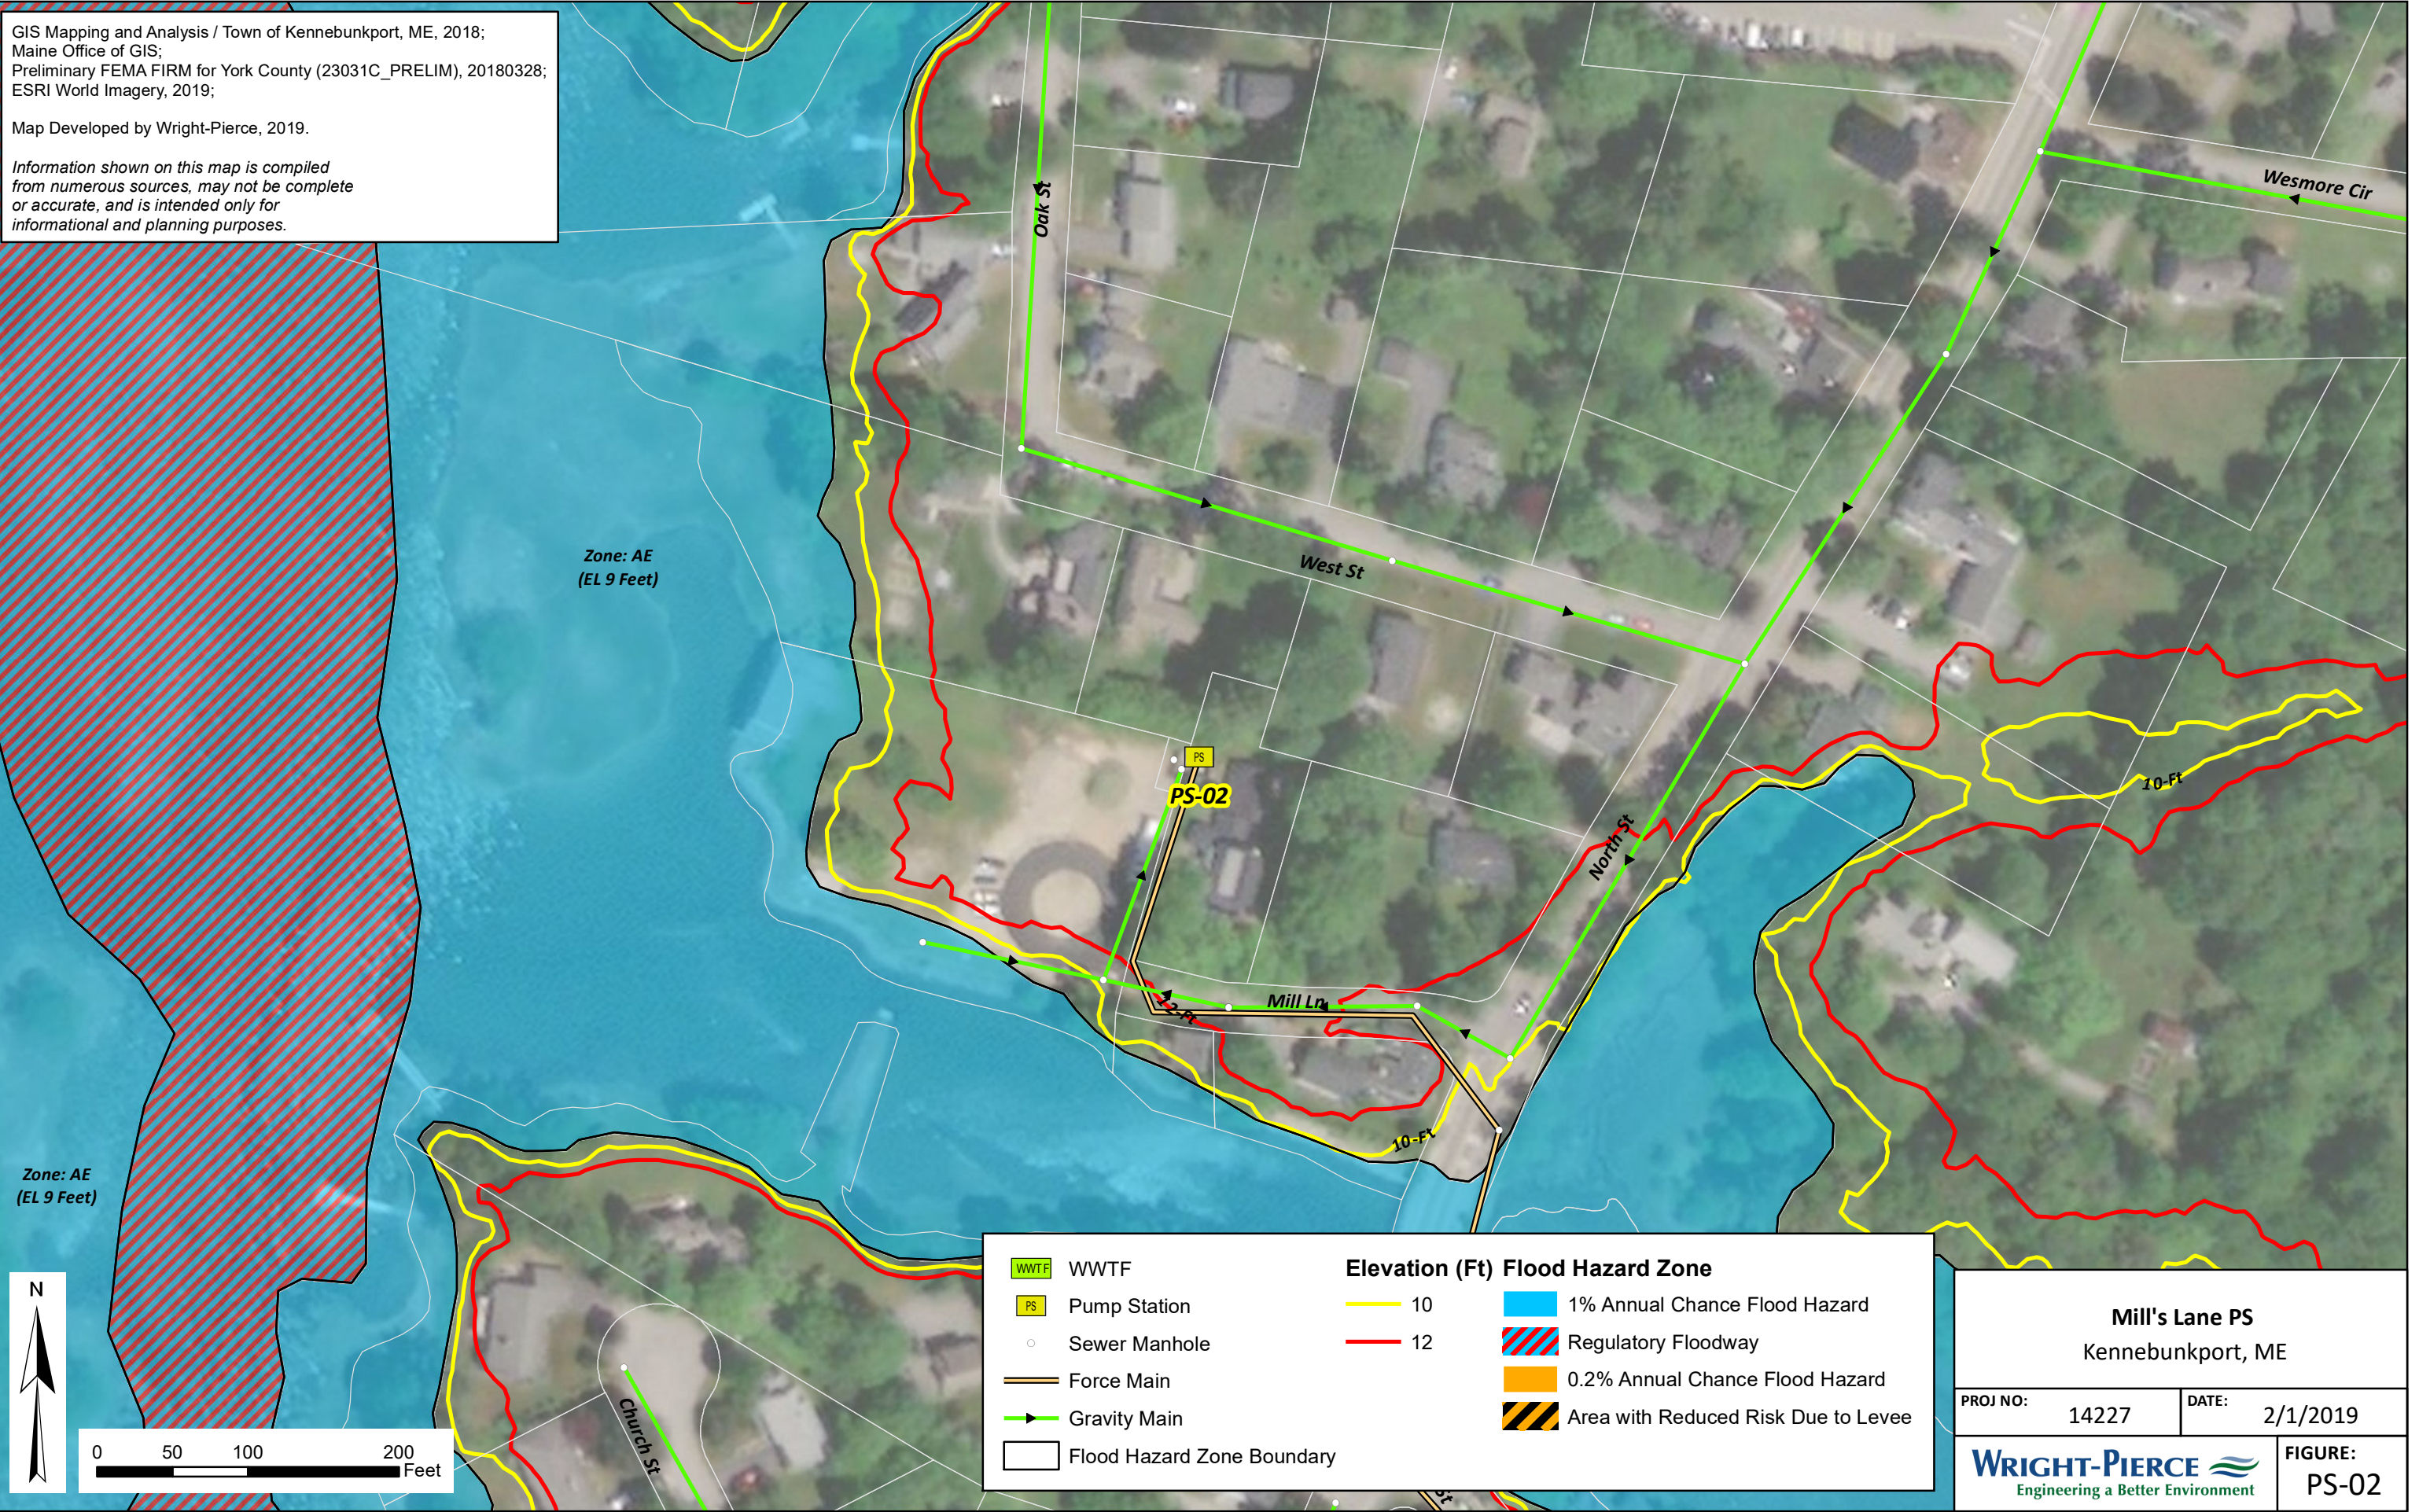
**Mill's Lane PS**  
Kennebunkport, ME

Zone: AE  
(EL 9 Feet)

10-Ft

Mills Lane (PS-02)	<ul style="list-style-type: none"> <li>Excessive precipitation</li> <li>Increased storm intensity</li> <li>Excessive wind speeds</li> </ul>	<ul style="list-style-type: none"> <li>Inoperable electrical equipment due to storm- and wind-related utility power losses.</li> <li>Equipment damage from falling trees during large storms and hurricanes.</li> </ul>	<ul style="list-style-type: none"> <li>The pump station is equipped with a stand-by generator and portable generator hook-up, therefore risk of electrical equipment failure during utility power loss is minimal.</li> <li>Large trees overhang the pump station and could damage above-ground equipment if they were to fall during large storms, excessive winds and/or hurricanes.</li> </ul>
Greene Street (PS-03)	<ul style="list-style-type: none"> <li>Riverine flooding</li> <li>Increased storm intensity</li> <li>Excessive wind speeds</li> </ul>	<ul style="list-style-type: none"> <li>Electrical equipment failure as a result of flooding from nearby Kennebunk River.</li> <li>Flooding as a result of sea level rise coupled with high astronomical tides.</li> <li>Accessibility issues at pump station as result of flooding.</li> <li>Inoperable electrical equipment due to storm- and wind-related utility power losses.</li> </ul>	<ul style="list-style-type: none"> <li>The bottom of the electrical control panel is 1.0 feet above the preliminary FEMA 100-year BFE for this area. The station's pumps are submersible and are at low risk of flood damage. The emergency generator is 0.5 feet above the preliminary FEMA 100-year BFE.</li> <li>Based on SLOSH model mapping, the pump station could be at risk of partial inundation if a Category 1 hurricane were to hit the region during mean high tide.</li> <li>Based on the potential 3.9 feet of sea level rise scenario for the region, the pump station may be at risk of partial inundation during high astronomical tides.</li> <li>Access to the station could be limited if a Category 1 hurricane were to hit the region during mean high tide.</li> <li>The pump station is equipped with a stand-by generator and portable generator hook-up, therefore risk of electrical equipment failure during utility power loss is minimal.</li> </ul>

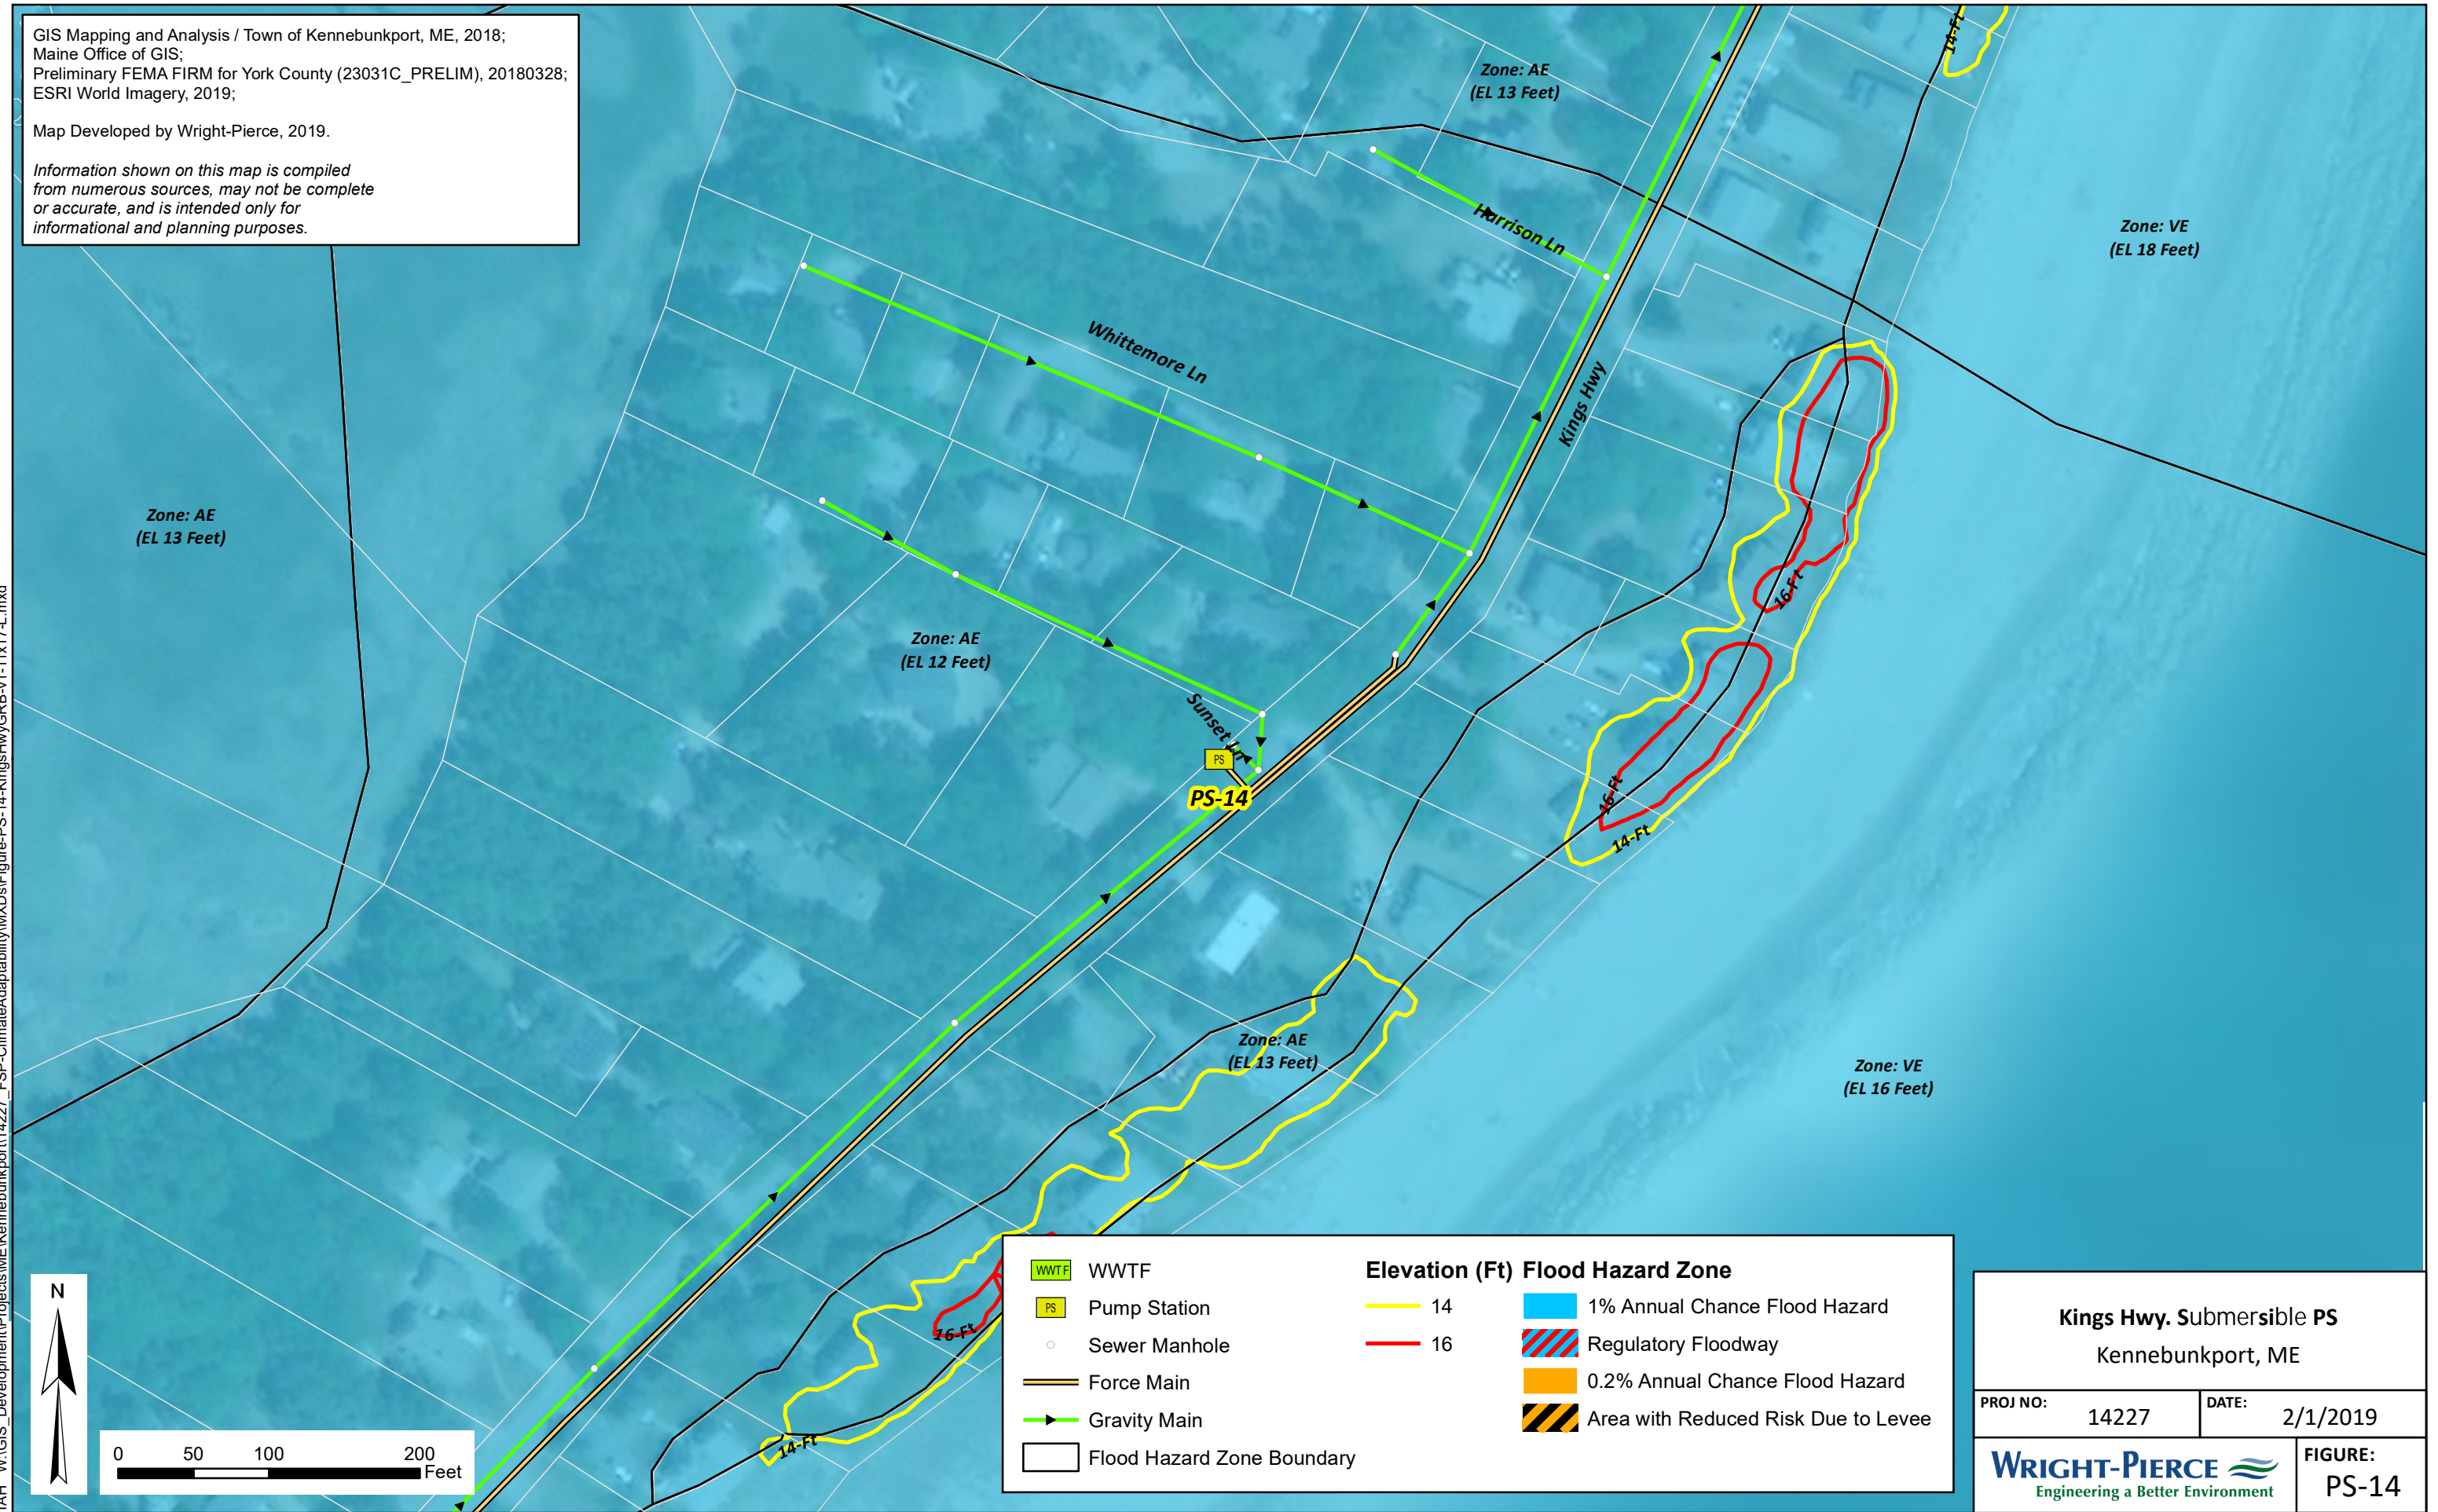
**Kings Hwy. Submersible PS**  
 Kennebunkport, ME

WWTF	14	1% Annual Chance Flood Hazard
Pump Station	16	Regulatory Floodway
Sewer Manhole		0.2% Annual Chance Flood Hazard
Force Main		Area with Reduced Risk Due to Levee
Gravity Main		
Flood Hazard Zone Boundary
